CONSERVING THE DEAN'S EYE

The stone tracery of the Dean's Eye window at Lincoln Cathedral had been failing for many years and the medieval stained glass required conservation, so by 2000 a complete reconstruction of the window was needed. Geoff Clifton was assigned to carry out the task of both preserving the original glass and ensuring that a stable, long-lasting structure was created around it. Here he writes about the history of the famous window and the process of careful and complicated restoration that was needed to save it.

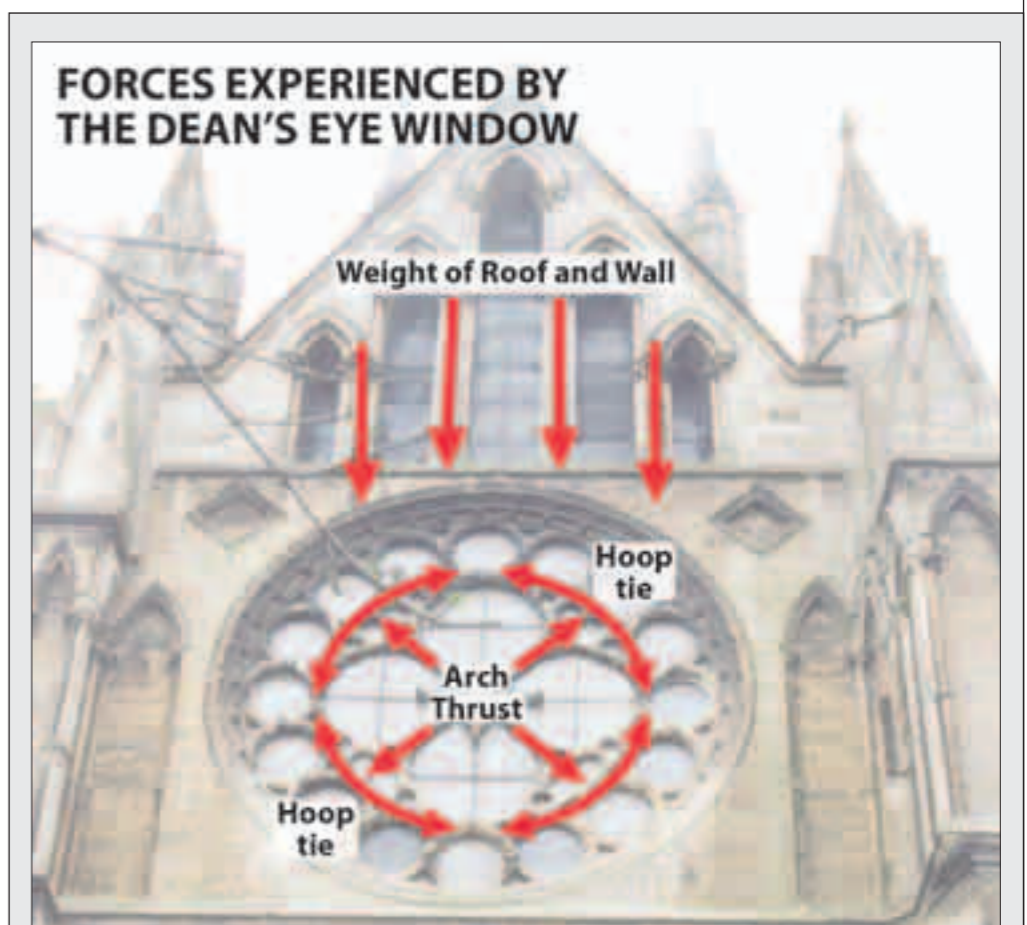
A view of the northwest gable and the Dean's Eye window prior to the restoration work. The image shows the structural lines of force that put stress on the window and the tracery. In addition to this but not marked up, are the pressure and suction forces experienced by the window from wind © Geoff Clifton

The thrusts from the inner section, acting as a shallow arch, were not likely to be restrained by the main gable wall to the transept, indeed the arch above the window had moved, thus causing the wall to slump. The Cathedral archives hint at instability of the wall on occasions in the past, with loose

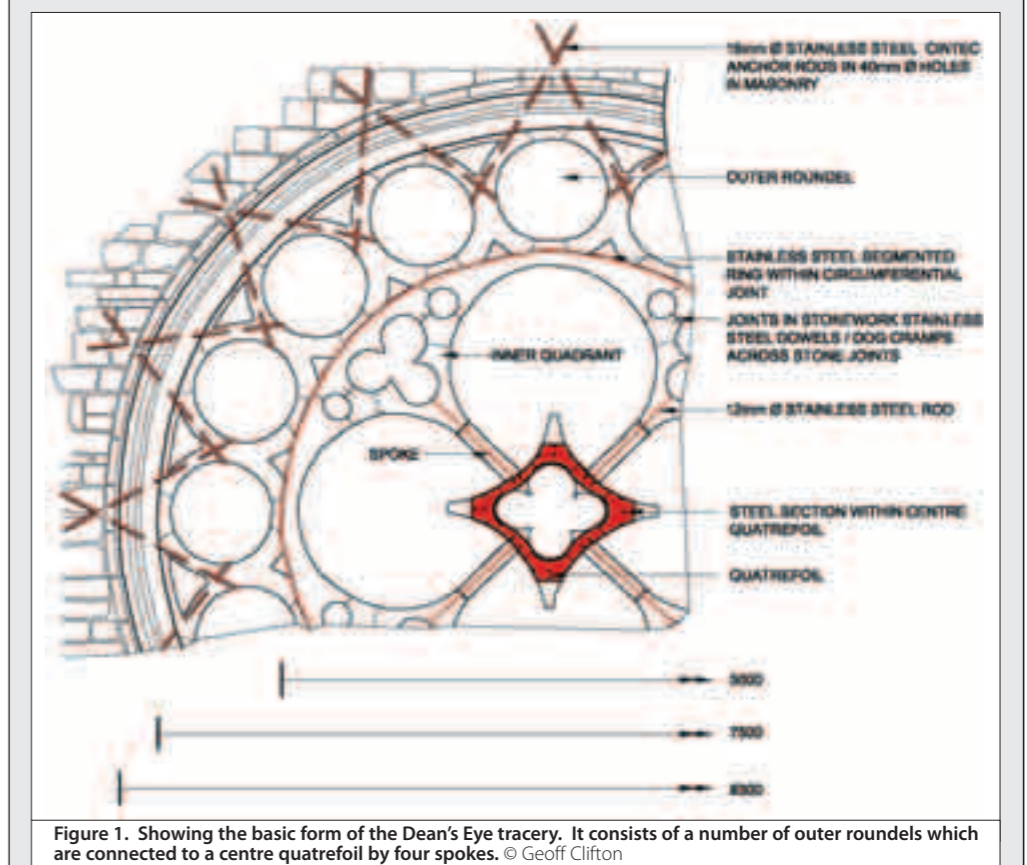
The central element of a rose window has to transmit the loads from each spoke around itself and then balance the load from the opposing spoke. In the case of the Dean's Eye there are only four spokes, far fewer than in most rose windows, so that the loads in each spoke are large and the spread between their interaction with the central element is farther apart.

Figure 1. Showing the basic form of the Dean's Eye tracery. It consists of a number of outer roundels which are connected to a centre quatrefoil by four spokes. © Geoff Clifton

Securing the connection between the outer roundel section and the transept gable wall was achieved by drilling holes through the 'X' shaped stones, between the roundels (see Figure 1), into the core of the transept wall and grouting stainless steel rods into these holes.

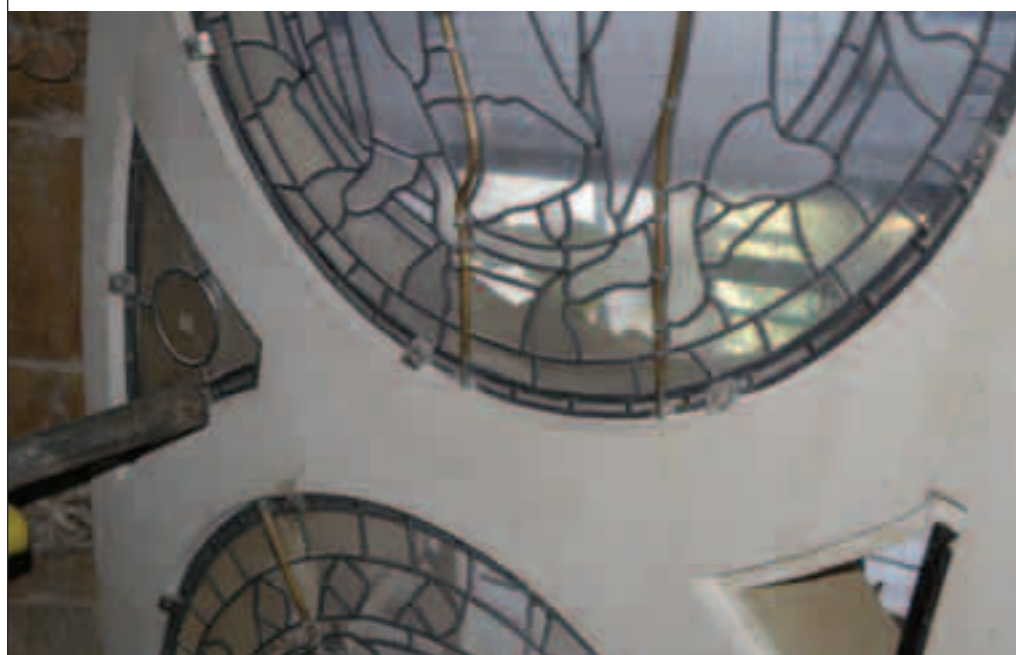
Isothermal glazing after it was attached to the tracery and before the glazing frame and stained glass were fitted. The lead came lines of the isothermal glazing were made to match the lines in the stained glass, so that from the exterior the window looks as if the stained glass is on the outside. It also shows the glazing bars (the bronze coloured vertical bars) that support the isothermal glazing © Geoff Clifton

The conservation of the glazing followed accepted practice for the protection of fragile historic glass by the use of isothermal glazing. New clear isothermal glass has been installed in the original location of the medieval glass, which, after conservation, has been fixed in new frames on the internal face of the tracery (see opposite).

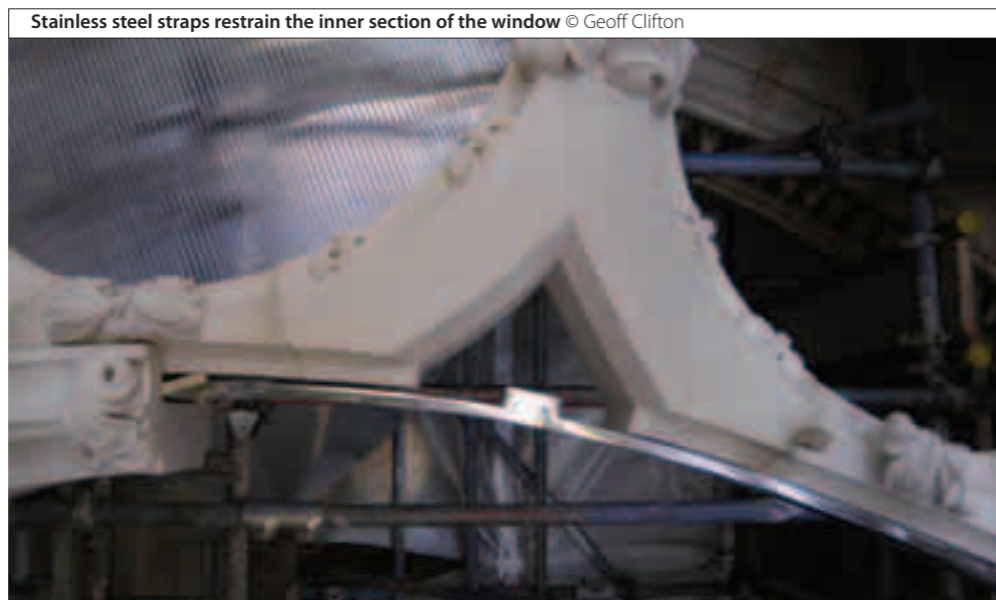
Stainless steel straps restrain the inner section of the window © Geoff Clifton

wall core and even possible local collapse. The pinnacles above the wall are in need of reconstructing which will reduce the mass restraint at some point in the future. All these factors imply a lack of the stiffness required to restrain any arch movement. The solution was to install a tight stainless steel strap around the inner section of the window – in the continuous joint between it and the outer roundels – thereby restraining the whole inner section.

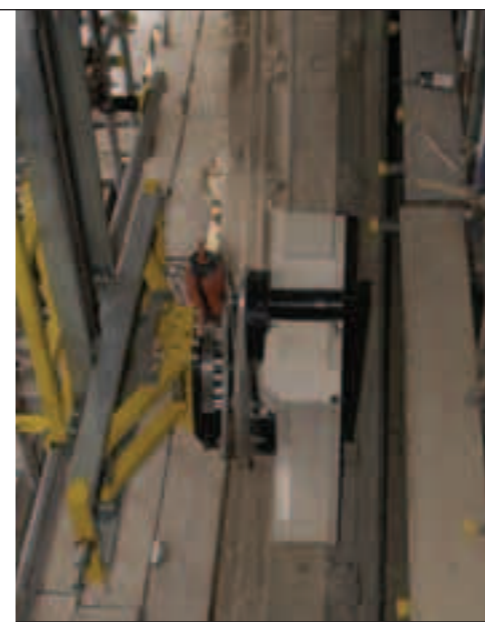
The stone handling device: the vertical grey bars are the rails on which the machine moves up and down, these are themselves attached to two horizontal bars which are attached to the structural scaffold, allowing the machine to traverse the whole window. Through this, individual stones can be aligned exactly in the right position, despite the distorted geometry of the tracery © Geoff Clifton

The exact positioning of the stones in the tracery was vital if it was to work as intended and the manoeuvring of stones weighing up to 500kg was a significant health and safety risk. To overcome these difficulties a stone handling device was specifically designed and manufactured. The device, shown above, was fixed on horizontal and vertical rails attached to the load bearing scaffold to allow movement in both directions. The attachment plate for holding stones could be moved in from the line of the scaffold, into the plane of the window, and tilted for exact placement. All the movements were controlled by screw jacks. The attachment plate had a range of bolt holes to hold every differently sized stone.

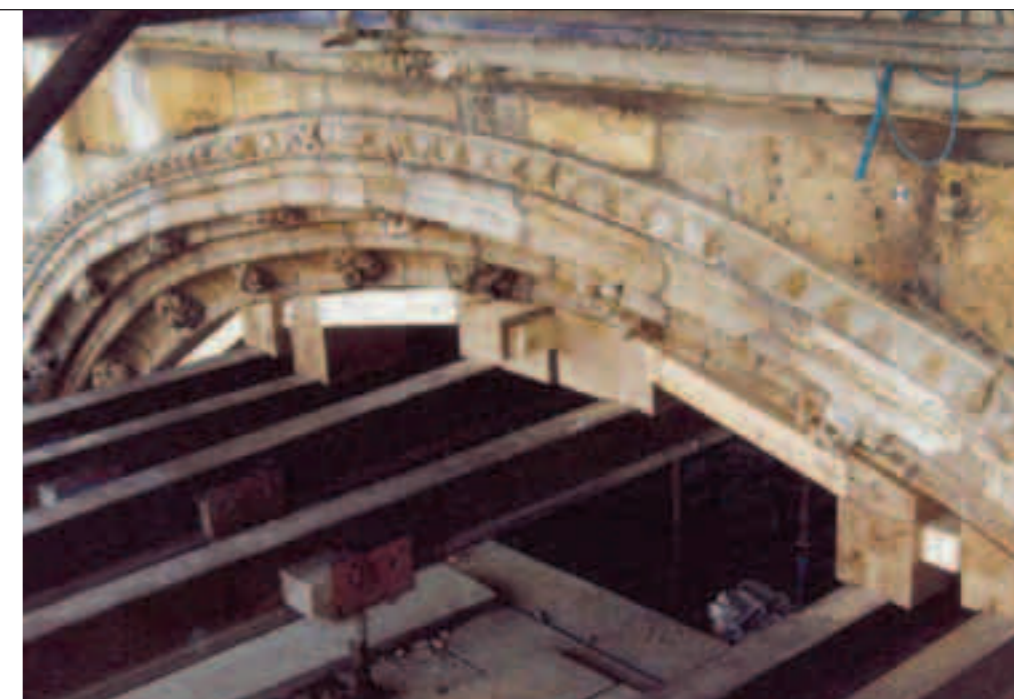
A view of the upper section of the arch with the tracery removed. The timber blocks were wedged up to the arch to keep it in place while lateral wedges were installed to stop the main wedges slipping. At any one time up to two of the steel support beams (needles) could be taken out to allow removal or installation of individual stones © Geoff Clifton

wall above the Dean's Eye while the tracery was removed. A system of monitoring the wall was also introduced to check for any movements whilst the dismantling and erection of the new window was carried out.
