SOLVING A HISTORICAL MYSTERY

Following defeat at the Battle of Bosworth Field in 1485, Richard III's body was lost for almost 530 years, until it was sensationally rediscovered beneath a Leicester car park in September 2012. Science and technology journalist Sarah Griffiths spoke to Professor Sarah Hainsworth FEng, Professor of Materials and Forensic Engineering at the University of Leicester, about how modern forensic engineering science helped to discover what happened on the battlefield.

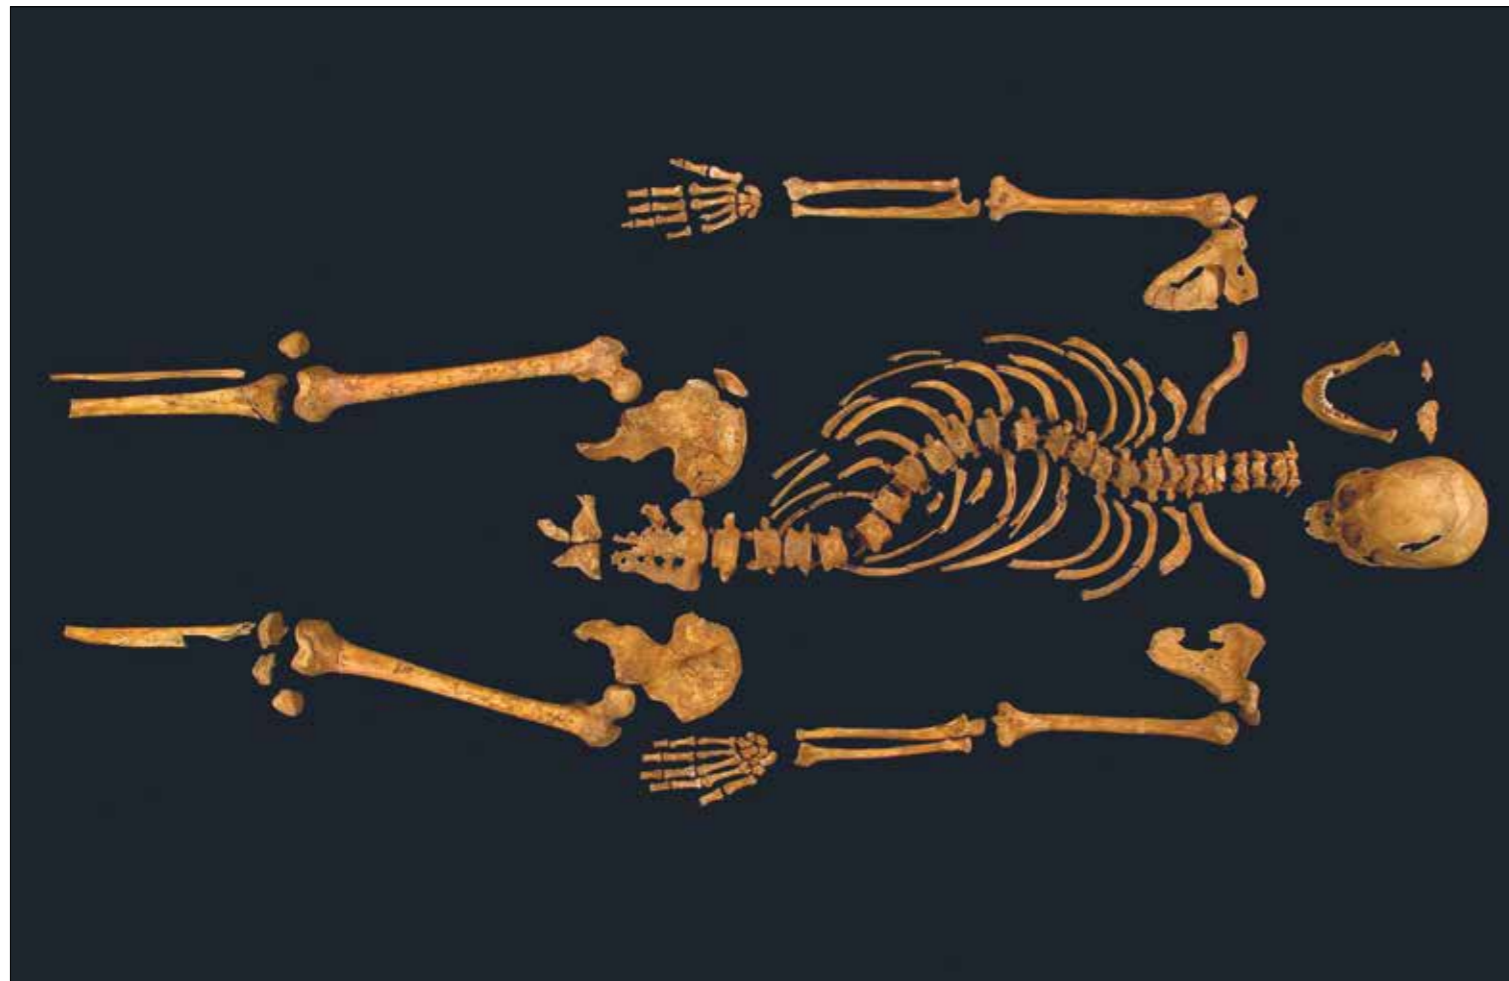
The skeleton found buried at the site of the former Grey Friars Abbey in Leicester displayed signs of trauma and the effect of the scoliosis on the spine, a condition that is generally associated with the traditional depiction of Richard III © University of Leicester

The complete skeleton was first laid out in an anatomical position, displaying considerable curvature of the spine, and underwent post-mortem CT scanning. The aim of the first

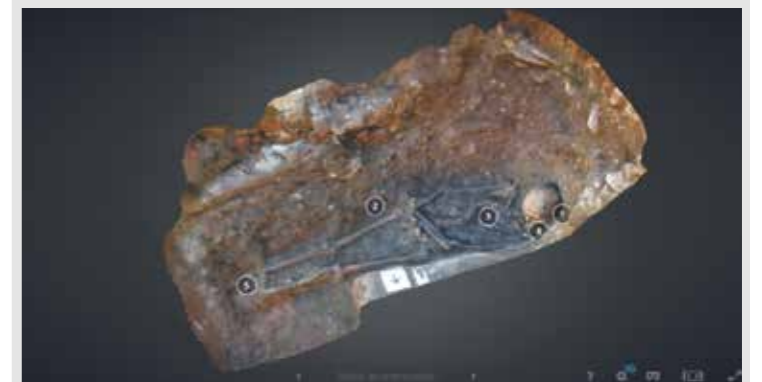
The 3D interactive digital reconstruction of King Richard III's grave allows it to be explored from all angles. It can be viewed at sketchfab.com/leicester-archaeology

Researchers from the Leicester LiDAR Research Unit in the Department of Geology mapped the exact shape of the grave using a terrestrial laser scanner. They placed the instrument at different points around the grave from where it fired laser pulses in a 360-degree arc to record the length of time taken to bounce off a surface and return to the scanner.

The information gathered at each point combined to create a 20-million-point cloud of the site, which recorded the excavated grave walls and even soil textures. This data was then amalgamated with a survey using more than 80 digital photographs of the grave, shot from different angles, which were used to build a 3D model of the void beneath the now-famous car park.
