# GOING UNDERGROUND

Engineers are completing a new five-storey basement underneath London's Claridge's, with no interruption to the hotel overhead. This extraordinary achievement has been made possible by a combination of traditional mining techniques and state-of-the-art structural and geotechnical engineering. Hugh Ferguson talked to engineers from McGee and Arup about the project, believed to be a world first for concurrent underground development and occupancy on such a scale.

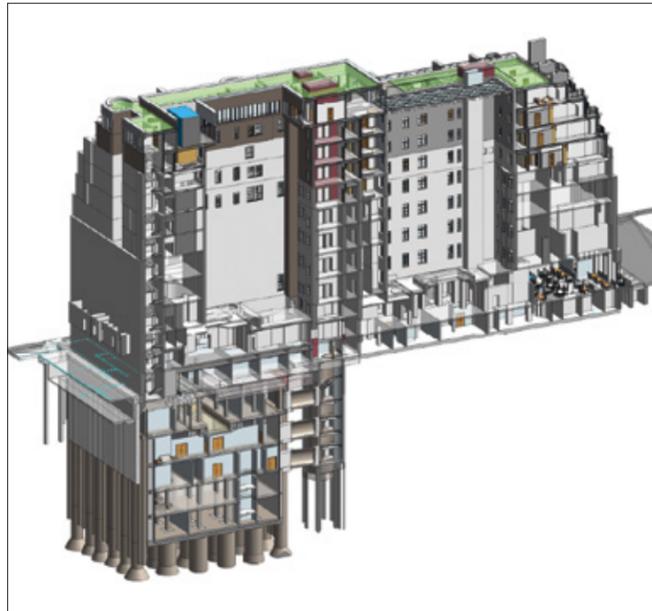
A cross-section through the front of the hotel shows the new basement below the art deco extension that was added in the 1920s © Arup

The 1920s eight-storey extension is supported by 61 steel columns resting on a 1.1-metre-thick, 50 metre by 25 metre reinforced concrete raft (a slab spread

out under the entire building) directly below the lower ground floor, with no pile foundations beneath. Some distance beneath the raft was firm London Clay, but unfortunately in between the raft and the clay were treacherous, uneven layers of gravel, up to half a metre thick, overlain by saturated silt with a high water content up to two metres thick, which was an alluvial flood plain feature of the former course of the River Tyburn. In its contained state, this silt had a high bearing capacity and could satisfactorily support the building overhead. However, once disturbed, below the water table the material flowed like 'running sand', or where it was a clayey silt, it behaved like toothpaste. Either way, both would damage the existing raft if a novel solution could not be found to address this ground risk.

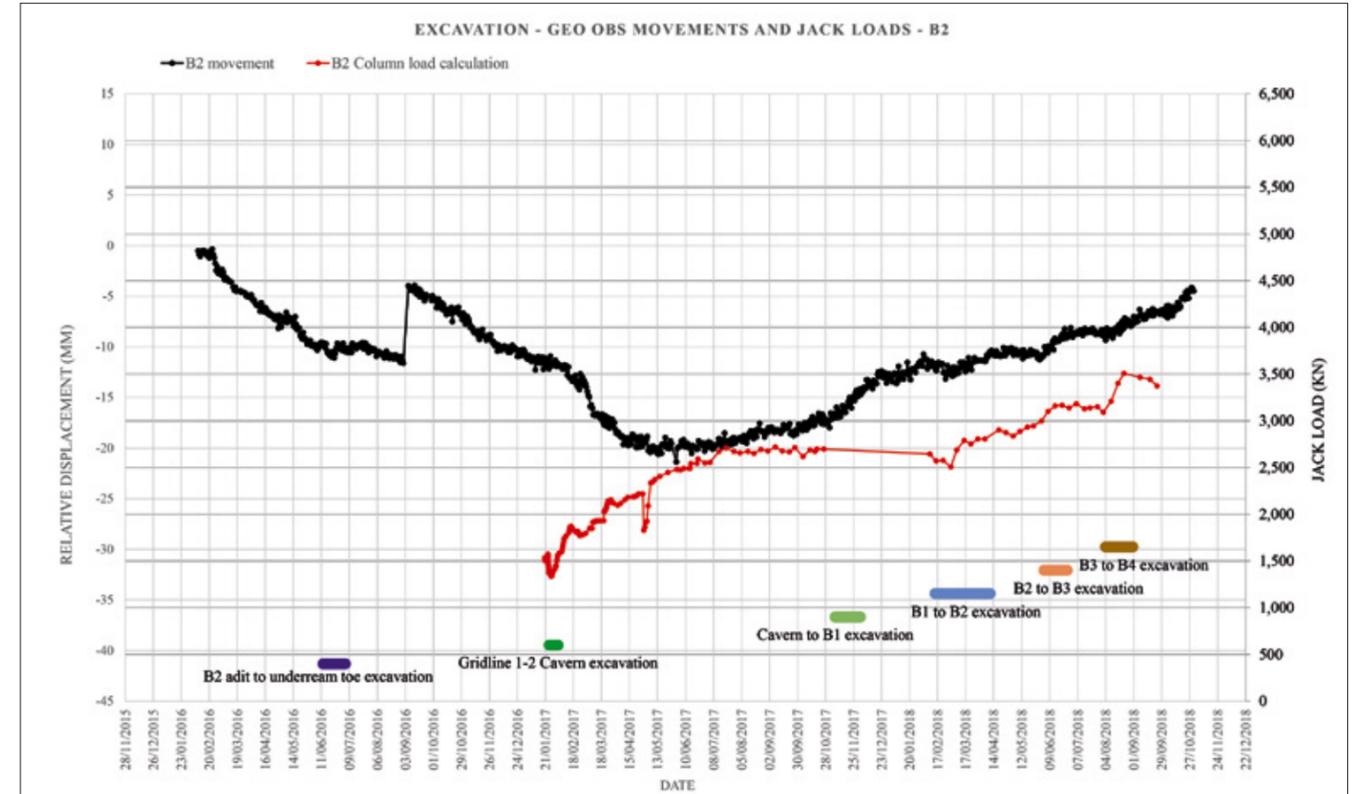
Measurements of loading (red line – from January 2017 when loading was transferred to the new columns) and displacement (black line) at the top of one of the 61 new columns at the base of the existing building, during construction works up to September 2018. The various construction activities are indicated beneath. The graph shows that, during top-down construction (B1 to B4 excavation), heave forces acting on the underside of the caisson foundation have been pushing this column upwards since October 2017 (black line), with a corresponding increase in the load in the jack, from what the engineers consider to be heave pressure © Arup

As each new column was completed, two 800 tonne hydraulic jacks were installed at the top to connect with the raft and existing columns above, which provided the ability to adjust loading and height on each column as required. Two jacks were required because the maximum travel was only 28 millimetres per jack, and it was expected that larger movements up or down would need to be made. Activating the jacks had the effect, not so much of pushing the hotel upwards, but of pushing the columns and piles downwards and absorbing the initial elastic settlement. Engineers measured loading simply by reading the hydraulic pressure in the jacks. Movement or changes in load did not happen suddenly, so there was time to monitor trends, check them against trigger limits set by the design, and plan any remedial action. At various stages of basement construction, excavation caused the ground below to heave, and load had to be removed from some of the jacks to maintain stability.

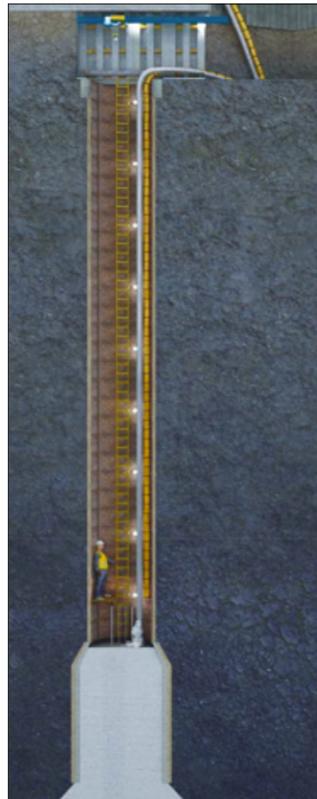
One of the 61 hand-dug caissons with a temporary steel lining, widened out below the bottom of the new basement where it was backfilled with concrete to form a new pile © McGee

Two miners used pneumatic spades to hand-dig each circular caisson through the dried silt and clay, installing a temporary lining formed of one-metre-deep bolted steel segments as they progressed. The diameter of the caissons was a critical decision: miners needed sufficient space to work and, at a later stage, to install the formwork and reinforcing steel for the new concrete columns, working in the cramped annular space between the columns and the caisson walls. However, the span of the raft that could be opened up to form the top of the caisson had to be kept to a minimum. A 'sweet spot' of 1.8 metres diameter was eventually chosen.

When the miners reached the bottom of the new basement 22 metres beneath the raft, the diameter was increased to 2.7 metres and more conventional, permanent precast concrete linings of up to four to six metres in depth were installed for the next section. Finally, the bottom of the excavation was 'belled out' to a diameter of up to 4.6 metres to form a broad, flat base for the new piles. The level of the bottom of each pile was carefully chosen to avoid going below the impermeable London Clay, which would have allowed groundwater to enter and required compressed air working. Reinforcing steel was placed and the caissons were then concreted to form solid

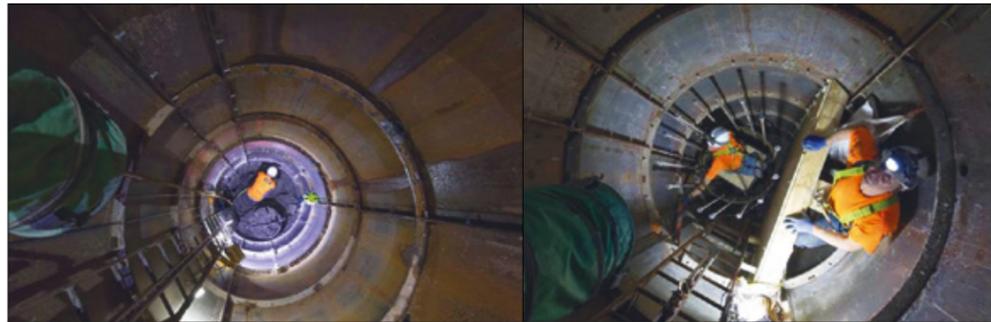
A miner hand excavates one of the 61 steel-lined caissons (left), while another places a reinforcing bar for a new column within the tight space of a hand-dug caisson (right) © McGee

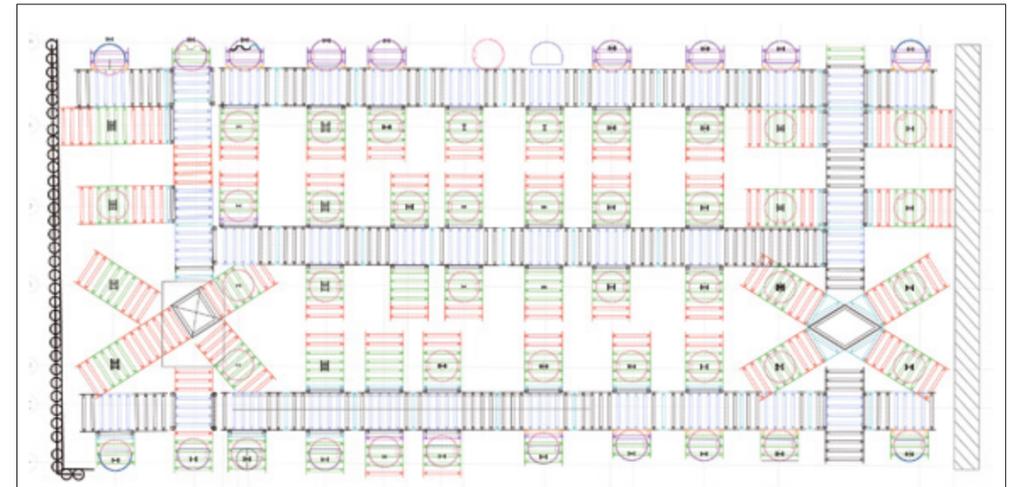
A diagram shows the three main tunnels (in blue) – named Tom, Dick and Harry – beneath the concrete raft, with numerous access tunnels to connect to the heads of each of the 61 caissons © McGee

The first six caissons and columns were treated as ‘trials’ to prove the feasibility of the proposed method, and only after their successful completion did the project turn into a full-blown contract. Tunnelling beneath the raft was extended, with three main tunnels – named Tom, Dick and Harry after the tunnels in *The Great Escape* – running most of the length of the raft, and with passageways connecting to the heads of all 61 caissons. There were so many tunnels and so much activity that it reminded those on site of an *Indiana Jones* movie.
